BULLETIN NO. 136

# NORTH COASTAL AREA INVESTIGATION

## Appendix E ENGINEERING GEOLOGY

Volume 11: Trinity River, Lower Eel River,  
and Klamath River Developments

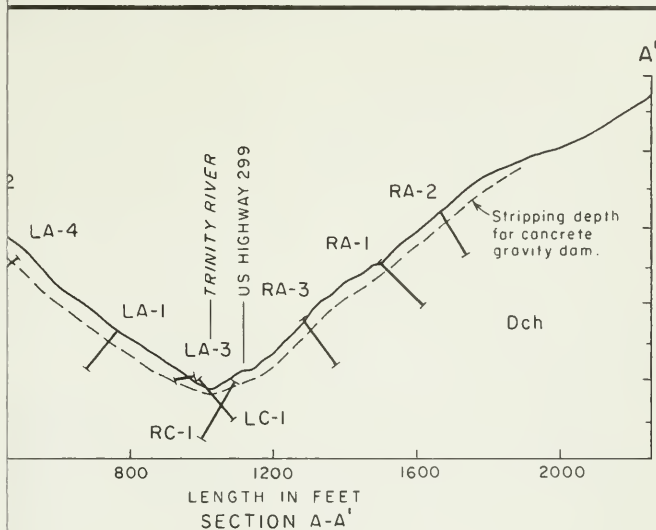
**GEOLOGIC MAP AND SECTION  
 HELENA DAMSITE-TRINITY RIVER**

- h HORNBLENDE META-ANDESITE
- elulla HARD MASSIVE, GRAYISH-GREEN META-ANDESITE
- ation
- 75 STRIKE AND DIP OF JOINTS
- 90 STRIKE OF VERTICAL JOINTS
- 20 STRIKE AND DIP OF FOLIATION
- 70 FAULT, SHOWING STRIKE AND DIP
- ~~~~~ SHEAR ZONE
- ~ SPRING
- RA-1 INCLINED CORE HOLE, SHOWING BOTTOM LOCATION
- A' GEOLOGIC SECTION LINE

. Part of the right abutment, especially in gullies, is covered by talus or a mixture of talus and soil cover. This material averages less than 3 feet in thickness, but the thickness varies from 1 foot on ridges to as much as 13 feet in gullies or breaks in slope. About 13 feet of such material was encountered in hole RA-3, but it is possible that this may include some badly broken and weathered bedrock. In many places bedrock is exposed at the surface such as where drill holes RA-1 and RA-2 were located.

Bedrock on the right abutment consists entirely of grayish-green massive hornblende meta-andesite. Except for the hornblende crystals, which are up to one-quarter inch in diameter, the rock is very fine-grained and dense. It is only slightly fractured below the estimated depth of stripping, and will provide a very satisfactory foundation. One core sample tested from hole RA-1 had an unconfined compressive strength of 13,680 psi.

A small shear or fault zone is exposed in a roadcut about 1,100 feet downstream from the axis. It consists of a zone 1 foot wide from which water was issuing at the rate of about one-half gpm. No displacement could be observed across it.

Below a drill hole depth of 30 feet in hole RA-1 and a depth of 40 feet in hole RA-2, water pressure tests indicated that the rock is tight. A pressure of 300 psi could be maintained with very little water loss. Fractures in hole RA-3 evidently are not nearly as tight as in the other two holes on the right abutment, as the maximum pressure obtainable during water testing of the hole was 65 psi at a water loss rate of about 4 gpm.

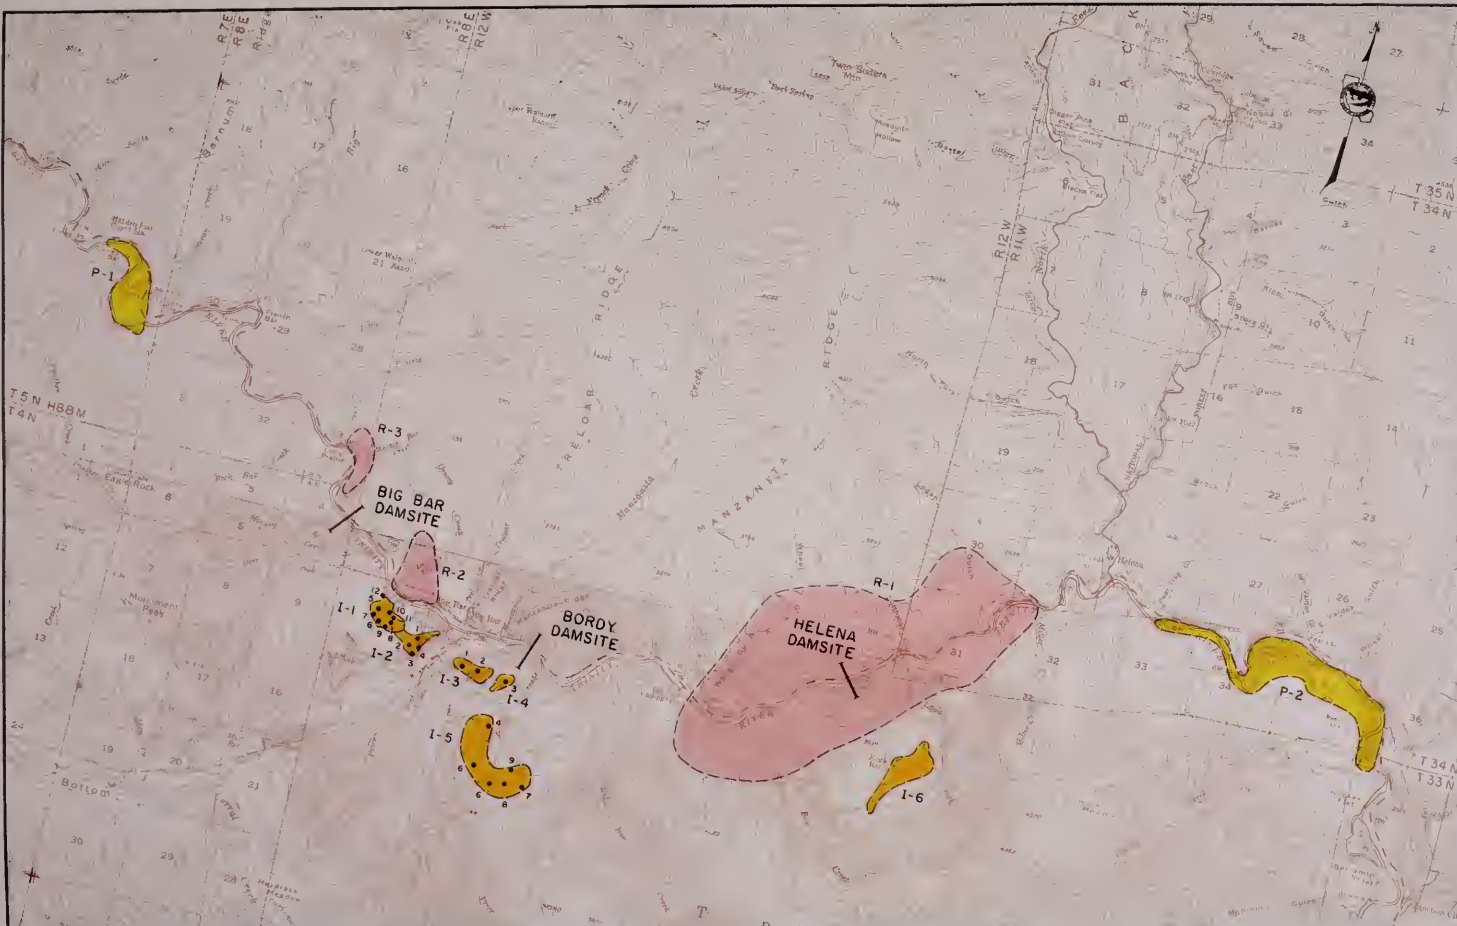
LOCATION OF CONSTRUCTION MATERIALS  
BIG BAR AND HELENA DAMSITES

- P-2 PERVIOUS MATERIAL OR CONCRETE AGGREGATE
- I-5 IMPERVIOUS TO SEMI-IMPERVIOUS MATERIAL
- R-2 ROCK-FILL OR RIPRAP MATERIAL
- BOUNDARY OF BORROW AREA
- LOCATION OF AUGER DRILL HOLE
- AXIS OF PROPOSED DAM

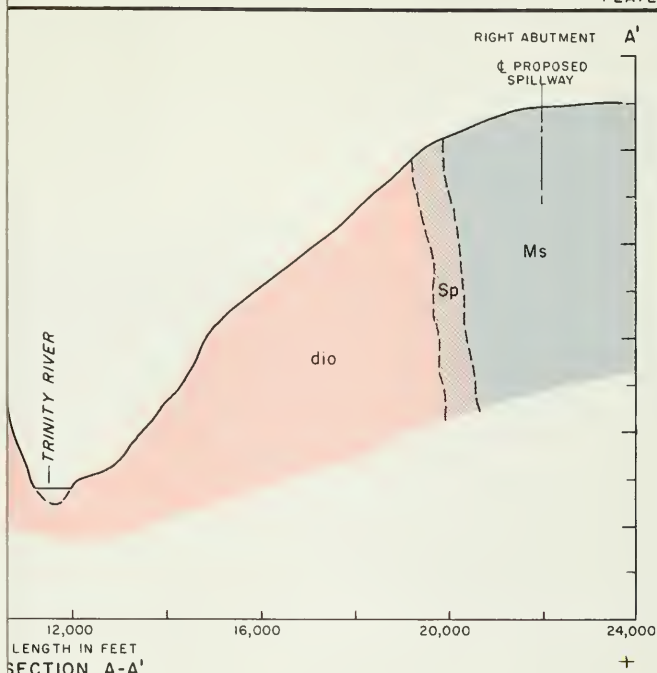
STATE OF CALIFORNIA  
THE RESOURCES AGENCY  
DEPARTMENT OF WATER RESOURCES  
NORTHERN BRANCH  
NORTH COASTAL AREA INVESTIGATION  
**GEOLOGIC MAP AND SECTION  
BURNT RANCH DAMSITE  
TRINITY RIVER**

EBRIS FROM CHINA SLIDE (1890).

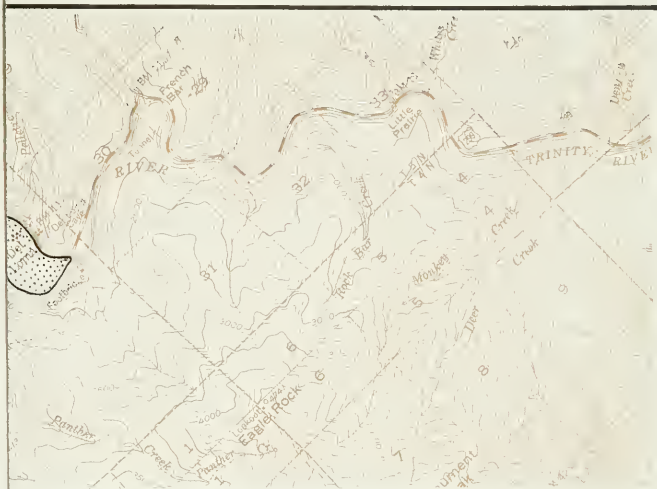
### LOCATION OF CONSTRUCTION MATERIALS BURNT RANCH DAMSITE

- IMPERVIOUS**

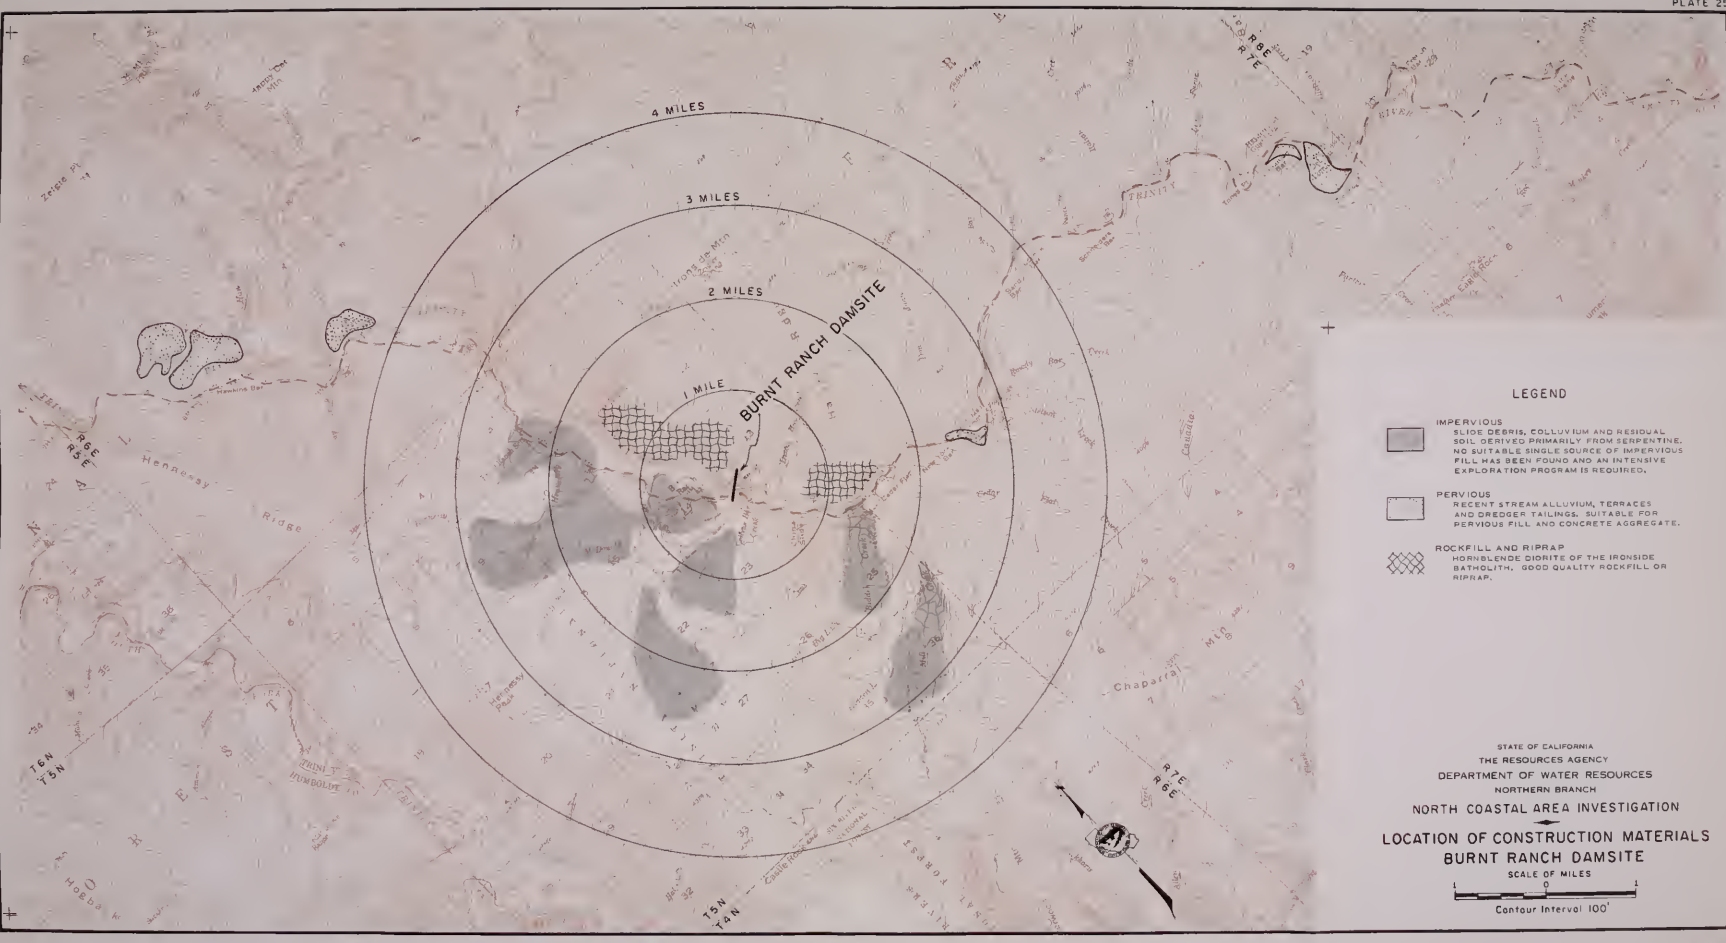
STATE OF CALIFORNIA  
THE RESOURCES AGENCY  
DEPARTMENT OF WATER RESOURCES  
NORTHERN BRANCH  
NORTH COAST AREA INVESTIGATION  
LOCATION OF CONSTRUCTION MATERIALS  
BURNT RANCH DAMSITE  
SCALE OF MILES  
Contour Interval 100'

- IMPERVIOUS  
SLIDE DEBRIS, COLLUVIUM AND RESIDUAL  
SOIL DERIVED PRIMARILY FROM SERPENTINE.  
NO SUITABLE SINGLE SOURCE OF IMPERVIOUS  
FILL HAS BEEN FOUND AND AN INTENSIVE  
EXPLORATION PROGRAM IS REQUIRED.
- PERVIOUS  
RECENT STREAM ALLUVIUM, TERRACES  
AND DREDGER TAILINGS. SUITABLE FOR  
PERVIOUS FILL AND CONCRETE AGGREGATE.
- ROCKFILL AND RIPRAP  
HORNBLENDE DIORITE OF THE IRONSIDE  
BATHOLITH. GOOD QUALITY ROCKFILL OR  
RIPRAP.

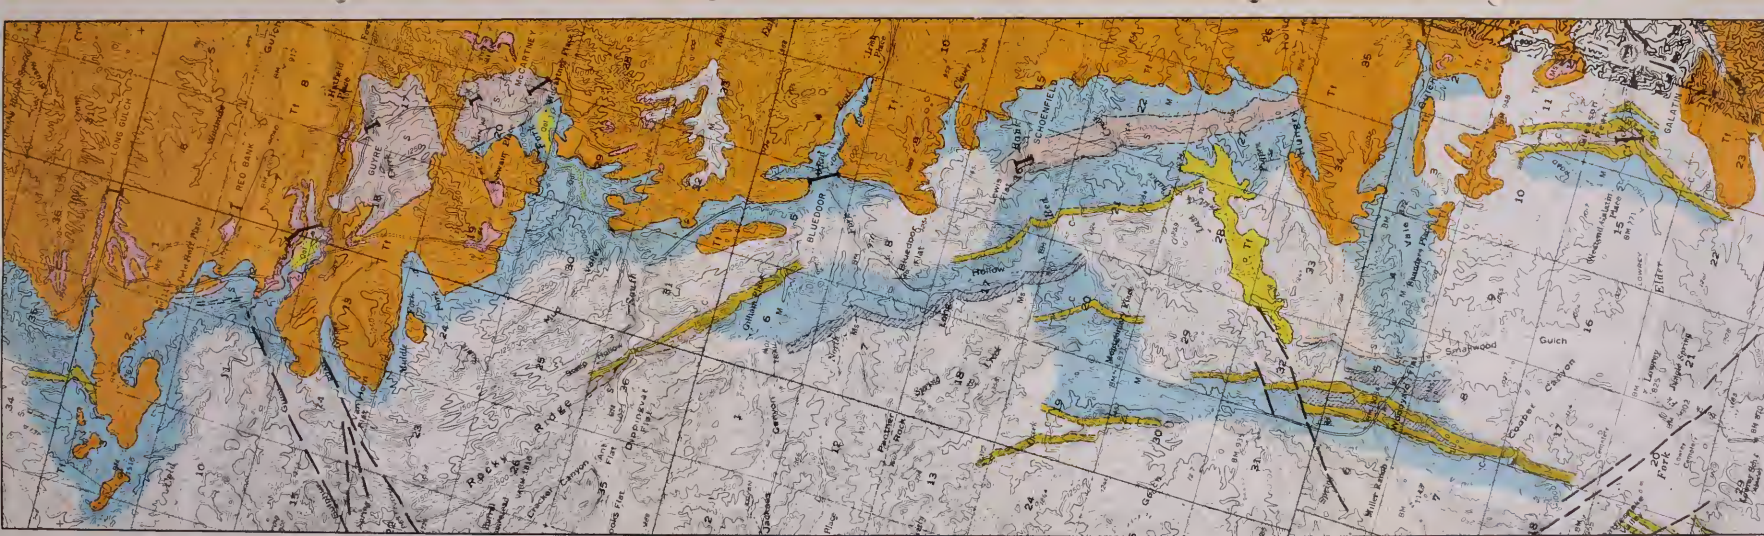
STATE OF CALIFORNIA  
 THE RESOURCES AGENCY  
 DEPARTMENT OF WATER RESOURCES  
 NORTHERN BRANCH  
 NORTH COASTAL AREA INVESTIGATION  
 AREAL GEOLOGY  
 WESTSIDE FEEDER SYSTEM  
 TRUEBLOOD RESERVOIR TO GALATIN RESERVOIR  
 SCALE OF MILES  
 Contour Interval 50

SANDSTONE  
 MUDSTONE AND SHALE  
 Limestone  
 MUDSTONE AND SHALE  
 SANDSTONE  
 MUDSTONE AND SHALE

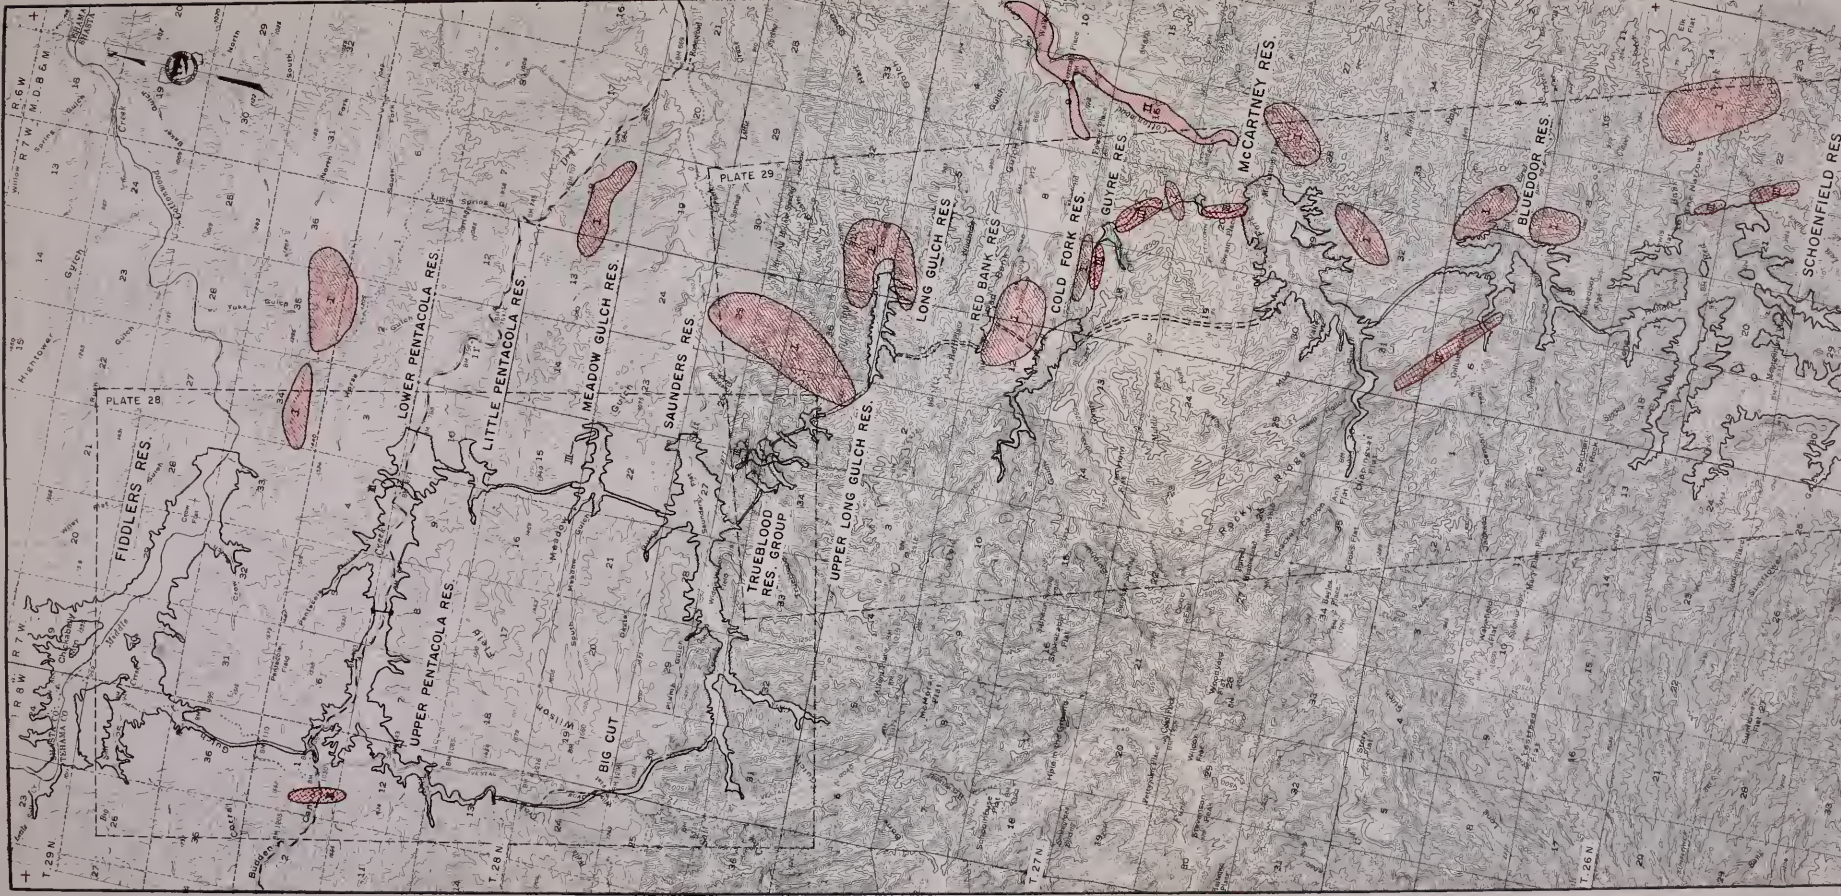
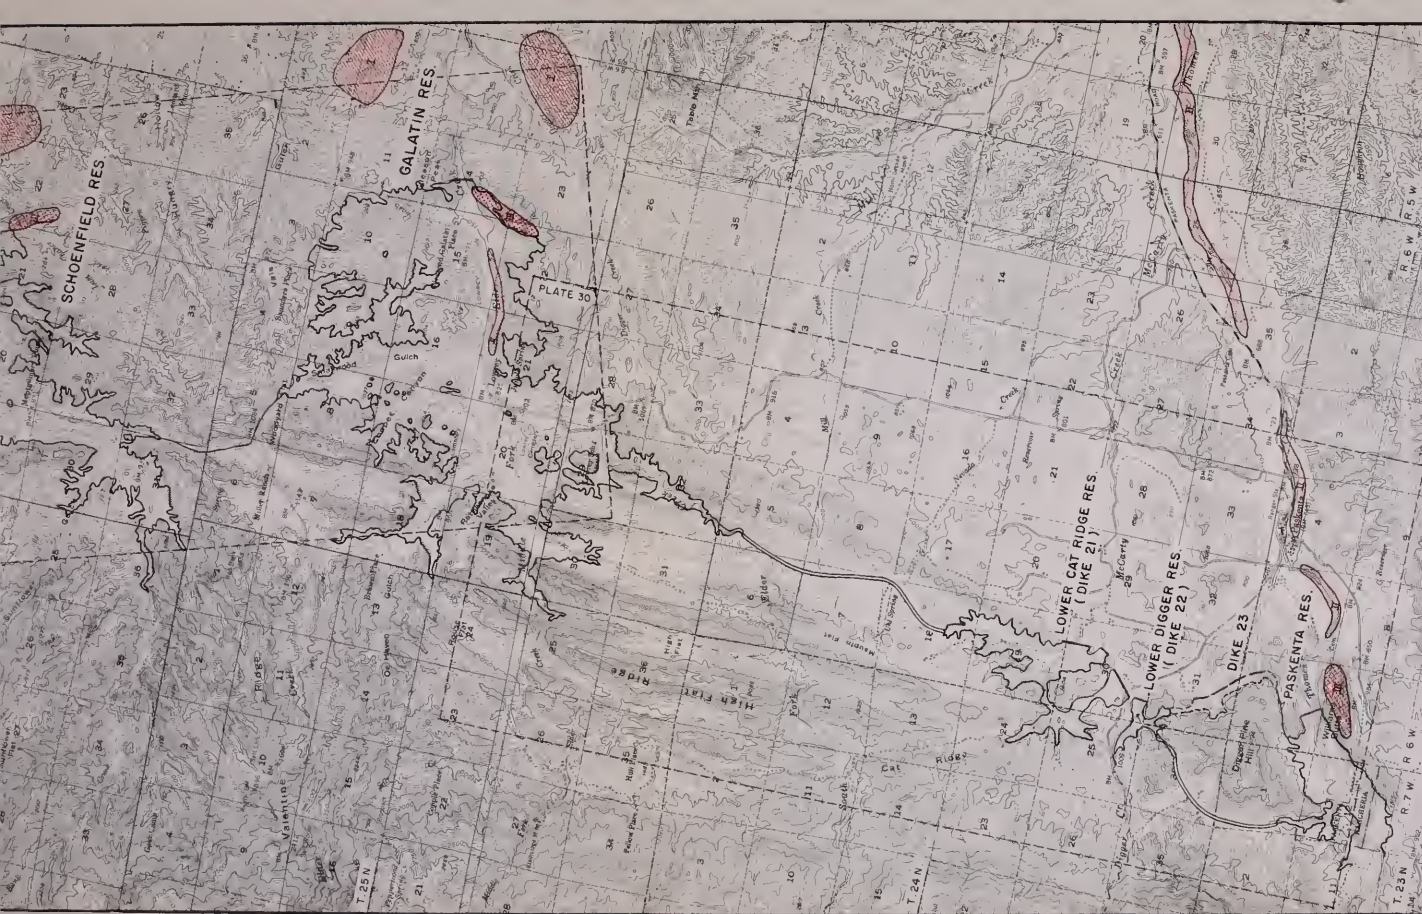
NORTH COASTAL AREA INVESTIGATION  
LOCATION OF CONSTRUCTION MATERIALS  
WESTSIDE FEEDER SYSTEM

- I IMPERVIOUS BORROW AREA
- II SOURCE OF PERVIOUS MATERIAL SUITABLE FOR FILTERS AND DRAINS
- III ROCKFILL AND RIPRAP
- PROPOSED RESERVOIRS
- OPEN CUT CONVEYANCE CHANNEL

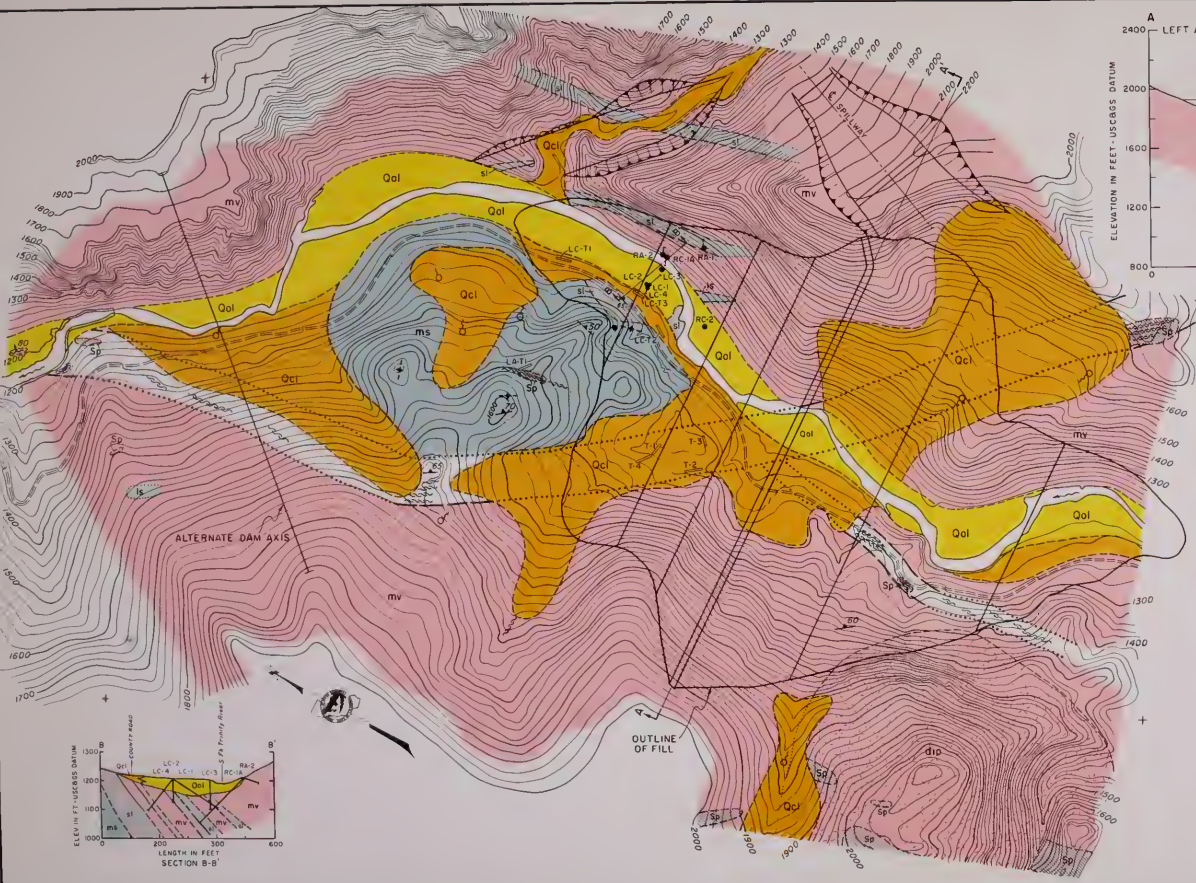
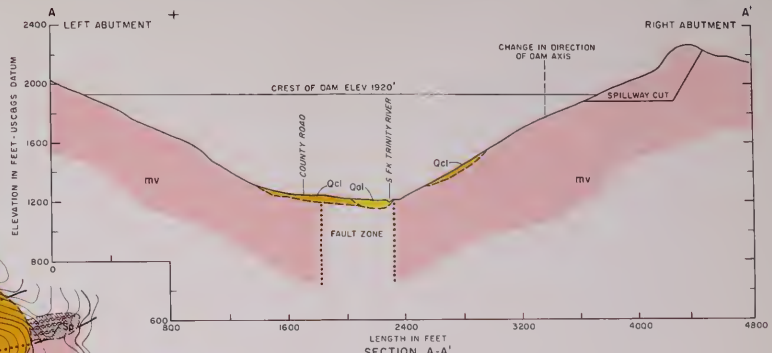
- LEGEND**
- QUATERNARY TO RECENT**
- Qal STREAM CHANNEL ALLUVIUM—SAND AND GRAVEL DEPOSITS IN THE RIVER CHANNEL, WITH OCCASIONAL SMALL LENSES OF SILT
  - Qcl COLLUVIUM—UNCONSOLIDATED SLOPEWASH, RESIDUAL SOIL, LANDSLIDE DEBRIS, TALUS AND MINOR TERRACES NEAR THE CHANNEL. AREAS OUTLINED ON THE MAP ARE UNDERLAIN BY DEEP, HEAVILY CONTINUOUS COLLUVIAL DEPOSITS. THE REMAINDER OF THE MAPPED AREA IS MANTLED BY RELATIVELY SHALLOW DISCONTINUOUS OVERBURDEN WHICH IS NOT SHOWN

- CHANCELLERIA FORMATION**
- ms METASEDIMENTS—UNDIFFERENTIATED MODERATELY METAMORPHOSED PREDOMINANTLY METASEDIMENTARY ROCK. ROCK TYPES INCLUDE SLATE, SCHIST, METAVOLCANIC ROCK, HORNfels, GNEISS, LIMESTONE, AND VEINS OF QUARTZ. THE INDIVIDUAL ROCK UNITS APPEAR TO BE DISCONTINUOUS AND THE MAP UNIT IS EXTREMELY COMPLEX STRUCTURALLY. ABOUT 80% OF THE MS UNIT CROPS OUT. THE REMAINDER OF THE AREA IS COVERED BY OVERBURDEN

- di INTRUSIVE DIORITE WITH SEGREGATIONS OR LENSES OF GABBRO AND SERPENTINE. THE ROCK IS GENERALLY VERY HARD AND MASSIVE
  - sp SERPENTINE—INTENSELY SHEARED, ALTERED AND FRACTURED ULTRABASIC INTRUSIVE ROCK

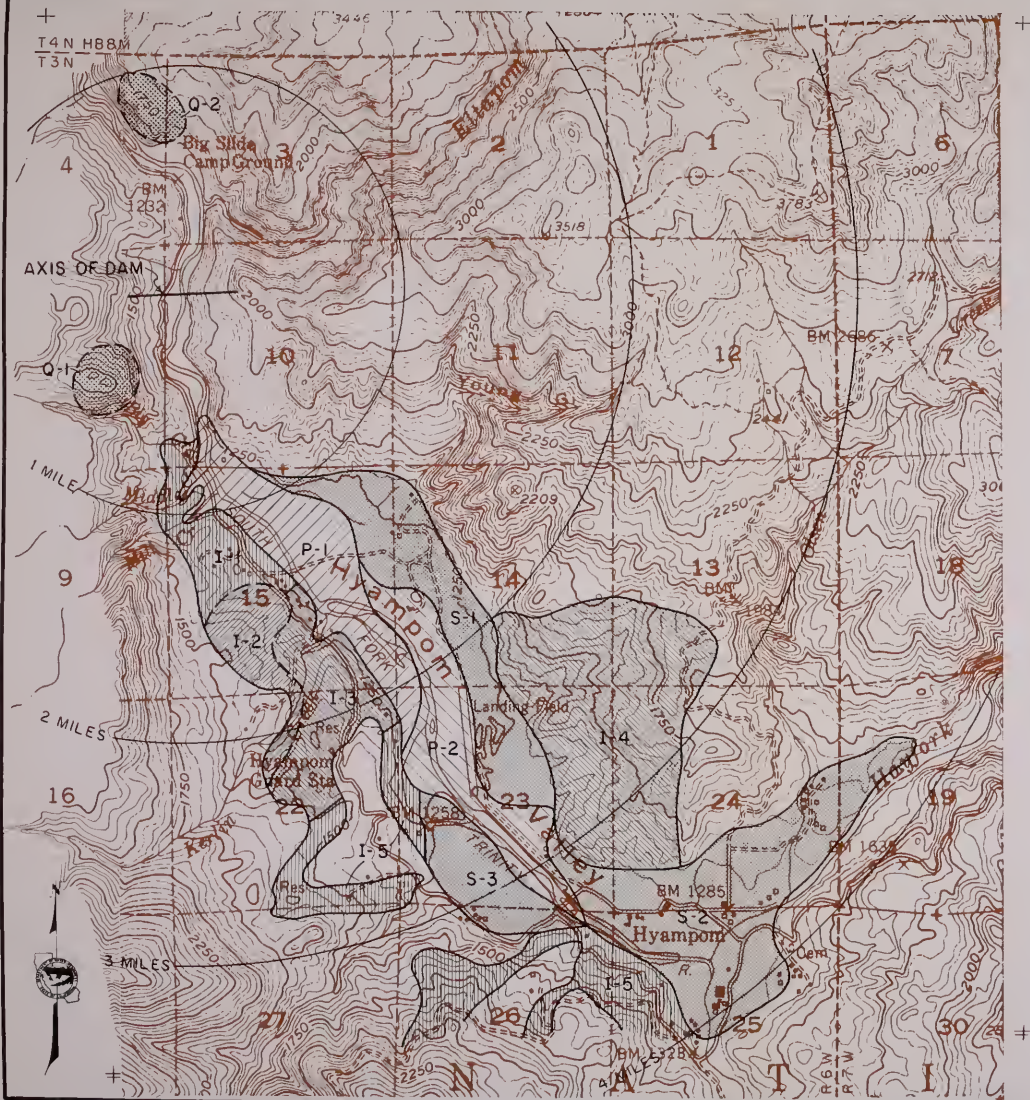
STATE OF CALIFORNIA  
THE RESOURCES AGENCY  
DEPARTMENT OF WATER RESOURCES  
NORTHERN BRANCH  
NORTH COASTAL AREA INVESTIGATION  
LOCATION OF CONSTRUCTION MATERIALS  
ELTAPOM DAMSITE

AREA	DESCRIPTION	ASSUMED AVERAGE DEPTH IN YARDS	QUANTITY YDS. <sup>3</sup> (BANK MEASURES)
I-1	IMPERVIOUS-WEAVERVILLE FORMATION-WEAKLY CONSOLIDATED CLAYEY GRAVEL, CLAYEY SILT AND SANDS.	16	9,500,000
I-2	IMPERVIOUS (SAME AS I-1)	2	1,000,000
I-3	IMPERVIOUS (SAME AS I-1)	20	17,000,000
I-4	IMPERVIOUS-WEAVERVILLE FORMATION-SHALE, SILTY SAND AND CLAYEY GRAVEL. WILL REQUIRE SELECTIVE EXCAVATION.	NOT ESTIMATED	PROBABLY MORE THAN 2 MILLION YDS. <sup>3</sup> OF USABLE MATERIAL.
I-5	IMPERVIOUS-WEAVERVILLE FORMATION (SAME AS I-1)	NOT ESTIMATED HIGHLY VARIABLE	PROBABLY 2-3 MILLION YDS. <sup>3</sup>
P-1	PERVIOUS OR AGGREGATE RIVER CHANNEL ALLUVIUM GRAVEL AND SAND.	10	9,700,000
P-2	PERVIOUS OR AGGREGATE SIMILAR TO P-1 BUT SOMEWHAT FINER GRAINED	10	12,600,000
S-1	SEMI-PERVIOUS-SLOPE-WASH TERRACE AND ALLUVIUM	5	7,000,000
S-2	SEMI-PERVIOUS (SIMILAR TO S-1)	5	12,000,000
S-3	SEMI-PERVIOUS SLOPEWASH AND TERRACE	2	1,000,000

Q-1 & Q-2	ROCK FILL-GREENSTONE, WITH LENSES OF SHALE-LIMESTONE & SERPENTINE	NOT ESTIMATED	SUFFICIENT QUANTITY OF ROCK FOR THE PROPOSED DAM CAN BE OBTAINED FROM EITHER Q-1 OR Q-2.

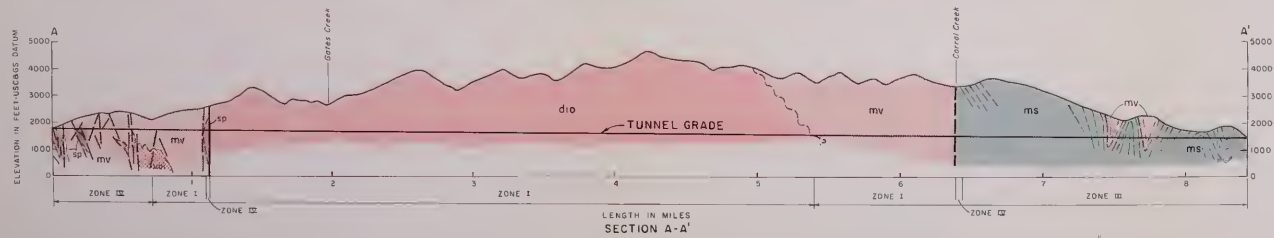
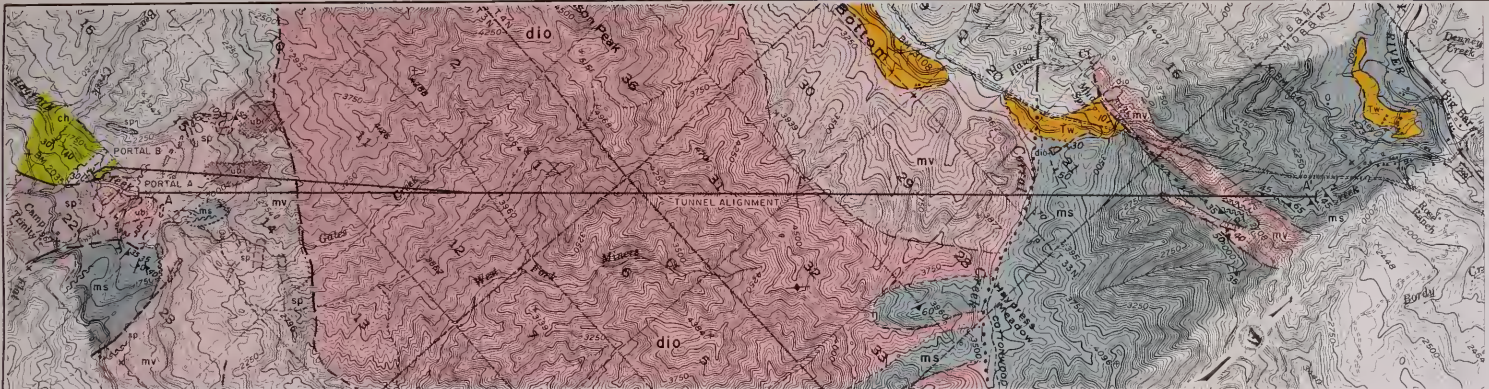
STATE OF CALIFORNIA  
THE RESOURCES AGENCY  
DEPARTMENT OF WATER RESOURCES  
NORTHERN BRANCH  
NORTH COASTAL AREA INVESTIGATION  
**GEOLOGIC MAP AND SECTION  
ELTAPOM-BIG BAR TUNNEL**  
SCALE OF MILES  
0 1 2  
Contour Interval 50

1. THIS MAP SHOWS DISTRIBUTION OF BEDROCK UNITS. RECENT SURFICIAL ACCUMULATION OF ALLUVIUM, SLOPESLASH AND LANDSLIDE DEBRIS ARE OMITTED.

3. REFER TO TEXT FOR A DETAILED DESCRIPTION OF TUNNELING CONDITIONS ZONES.

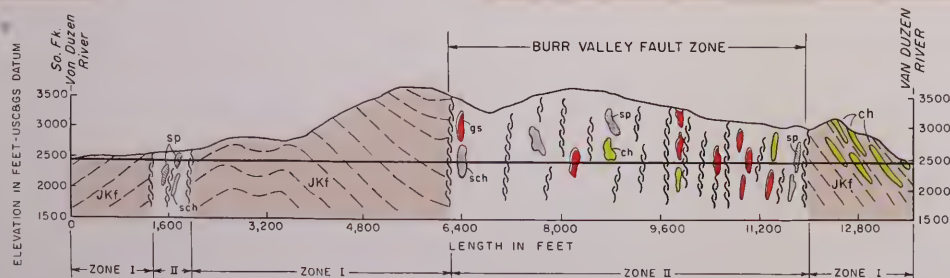
## GEOLOGIC MAP AND SECTION LARABEE TUNNEL

1. THIS MAP SHOWS THE DISTRIBUTION OF BEDROCK UNITS. RECENT SURFICIAL ACCUMULATIONS OF ALLUVIUM, SLOPE WASH AND LANDSLIDE DEBRIS ARE OMITTED.
2. THE GEOLOGIC STRUCTURE SHOWN ON THE CROSS-SECTION IS BASED ON RECONNAISSANCE WORK AND SHOULD BE CONSIDERED AS PARTIALLY DIAGRAMMATIC.
3. REFER TO THE TEXT FOR A DETAILED DESCRIPTION OF TUNNELING CONDITIONS ZONES.

GEOLOGIC SECTION AND TUNNELING CONDITIONS ZONES

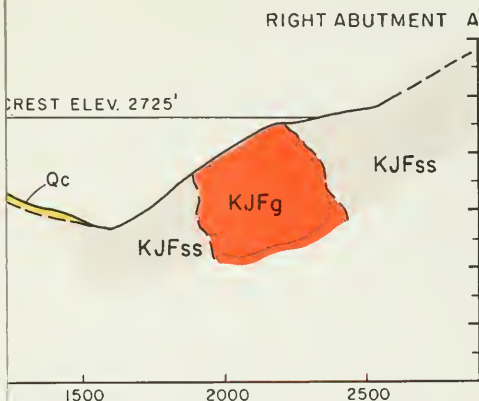
GEOLOGIC MAP AND SECTION  
EATON DAMSITE-VAN DUZEN RIVER

LENGTH IN FEET  
SECTION A-A'

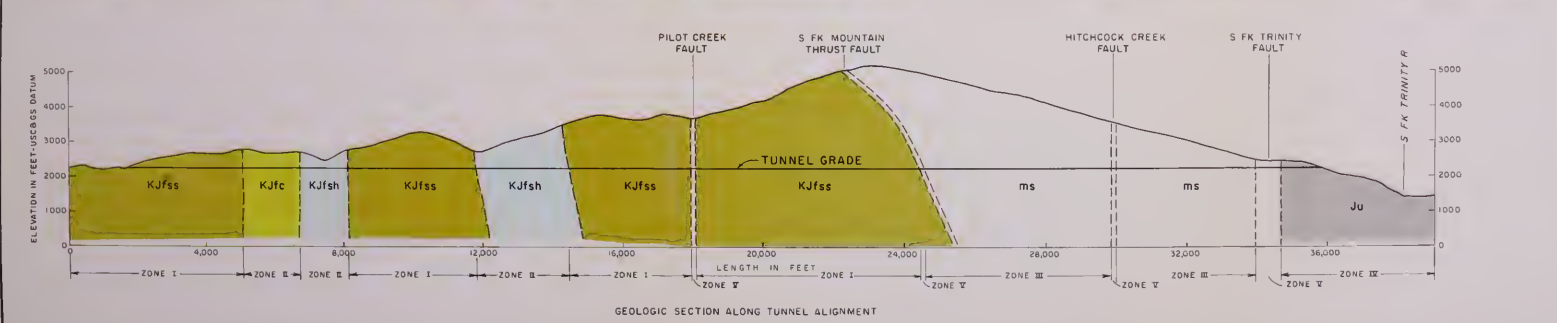
**GEOLOGIC MAP AND SECTION  
SOUTH FORK TUNNEL  
PILOT CREEK ALIGNMENT**

**ZONE I** ZONE I INCLUDES AREAS UNDERLAIN BY FRANCISCAN SANDSTONE WITH SUBORDINATE INTERBEDS OF SHALE. TUNNELING CONDITIONS WILL RANGE FROM MODERATELY BLOCKY AND SEAMY TO CONSIDERABLY CRUSHED.

**ZONE II** ZONE II CONSISTS OF BELTS WITHIN THE FRANCISCAN FORMATION WHICH ARE UNDERLAIN BY A HIGH PERCENTAGE OF SHALE AND CHERT OR WHERE A HIGH DEGREE OF SHEARING HAS OBSERVED.

**ZONE IV** THIS ZONE CONSISTS OF SLATES AND PHYLLITES OF THE GALIC FORMATION. TUNNELING CONDITIONS WILL BE SCHISTOSE OR FOLIATED AND VERY BLOCKY AND SEAMY IN MINOR SHEARS.

**ZONE V** THIS ZONE DESCRIBES THE TUNNELING CONDITIONS WITHIN THE MAJOR FAULT ZONES PENETRATED BY THE PROPOSED TUNNEL LINES. EXTREMELY HAZARDOUS TUNNEL DRIVING IS ANTICIPATED. ABOUT 10 PERCENT OF ZONE V WILL BE "WET HEADING" TUNNELING.

GEOLOGIC SECTION ALONG TUNNEL ALIGNMENT

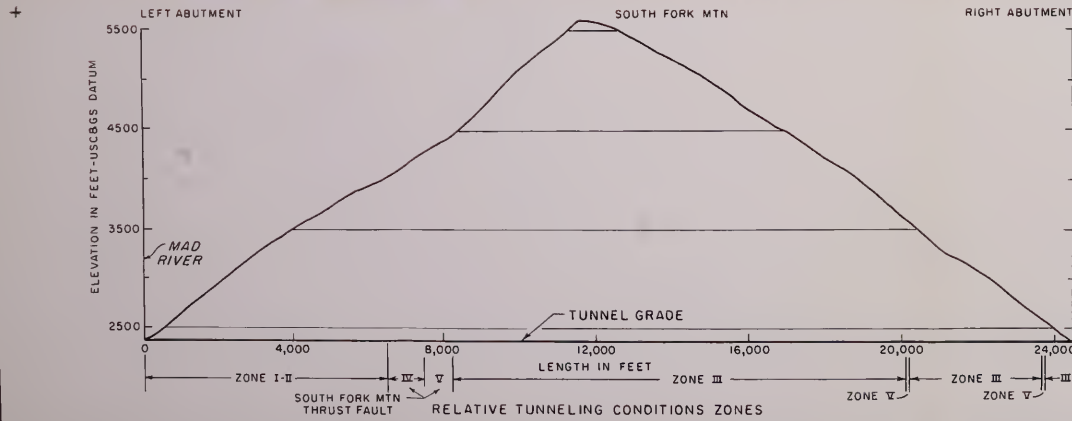
GEOLOGIC MAP AND SECTION  
SOUTH FORK TUNNEL  
SULPHUR GLADE ALIGNMENT

ZONE I	ZONE I INCLUDES AREAS UNDERLAIN BY FRANCISCAN SANDSTONE WITH SUBORDINATE INTERBEDS OF SHALE. TUNNELING CONDITIONS WILL RANGE FROM MODERATELY BLOCKY AND SEAMY TO COMPLETELY CRUSHED
II	ZONE II CONSISTS OF BELTS WITHIN THE FRANCISCAN FORMATION WHICH ARE UNDERLAIN BY A HIGH PERCENTAGE OF SHALE OR WHERE A HIGH DEGREE OF SHEARING WAS OBSERVED
III	THIS TUNNELING ZONE CONSISTS OF THE SOUTH FORK MOUNTAIN SCHIST FORMATION, DUE TO POOR OUTCROPS THE PROPERTIES OF THIS UNIT WITH RESPECT TO TUNNELING ARE VIRTUALLY UNKNOWN
IV	THIS ZONE CONSISTS OF A PORTION OF THE SOUTH FORK MOUNTAIN FAULT ZONE. TUNNELING CONDITIONS WILL BE VERY BLOCKY AND SEAMY
V	THIS ZONE DESCRIBES THE TUNNELING CONDITIONS WITHIN THE MAJOR FAULT ZONES PENETRATED BY THE PROPOSED TUNNEL LINES. EXTREMELY HAZARDOUS TUNNEL DRIVING IS ANTICIPATED. ABOUT 75 PERCENT OF ZONE V WILL BE "WET HEADING" TUNNELING

NOTE: GEOLOGIC FEATURES AND TUNNELING CONDITIONS ZONES ARE BASED UPON DATA OBTAINED FROM "GEOLOGICAL ENGINEERING STUDY OF PROPOSED TUNNEL THROUGH SOUTH FORK MOUNTAIN, TRINITY COUNTY, CALIFORNIA" BY LOUIS V. GIRARD, AND "GEOLOGICAL MAP OF CALIFORNIA, REDDING SHEET," CALIFORNIA STATE DIVISION OF MINES AND GEOLOGY.

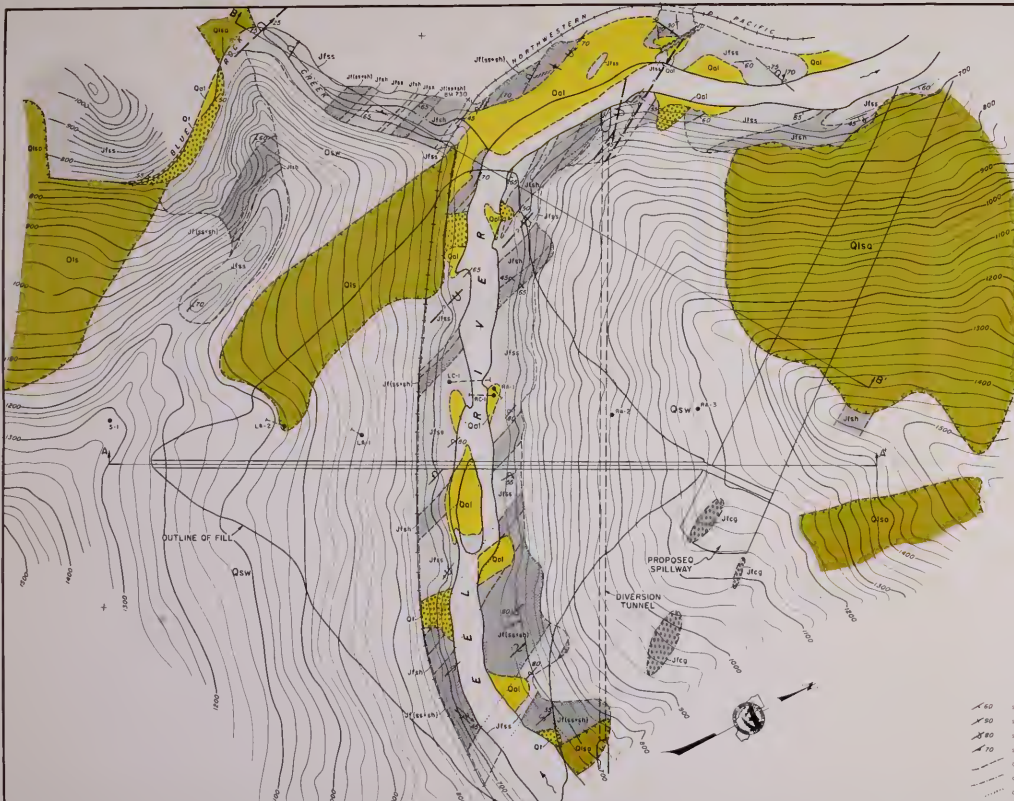
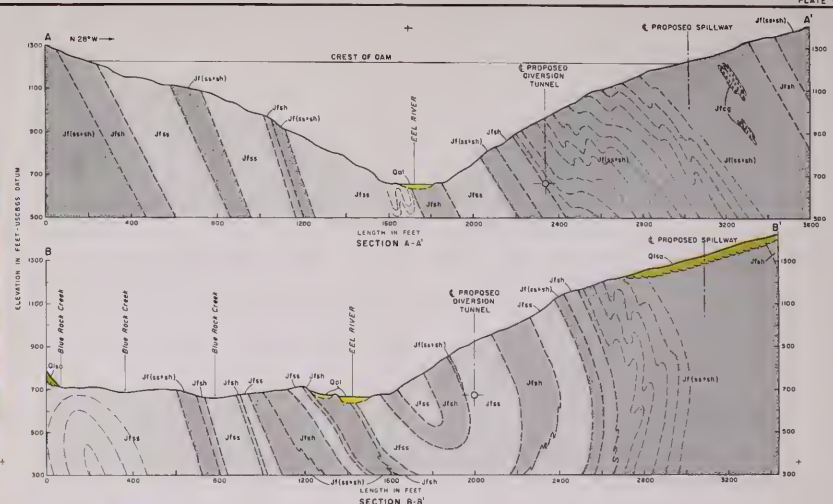
STATE OF CALIFORNIA  
THE RESOURCES AGENCY  
DEPARTMENT OF WATER RESOURCES  
NORTHERN BRANCH  
NORTH COASTAL AREA INVESTIGATION  
**GEOLOGIC MAP AND SECTIONS**  
**BELL SPRINGS DAMSITE**  
**EEL RIVER**

ALL ANTICLINE AND SYNCLINE  
ALL OVERTURNED SYNCLINE, SHOWING DIP OF AXIAL PLANE  
AND DEGREE OF PLUNGE  
XJOR OVERTURNED SYNCLINE. (?) WHERE DOUBTFUL  
XJOR OVERTURNED ANTICLINE  
GEOLOGIC SECTION LINE  
NOTE: SOME CROSS SECTION ROCK UNITS ARE  
EXTRAPOLATED BENEATH SLOPE WASH FROM  
STREAMSIDE EXPOSURES
